Flight Demonstration of X-33 Vehicle Health Management System Components on the F/A-18 Systems Research Aircraft

*Keith A. Schweikhard, W. Lance Richards and John Theisen
NASA Dryden Flight Research Center
Edwards, California*

9. SPONSORING/MONITORING AGENCY NAME(S) AND ADDRESS(ES) National Aeronautics and Space Administration Washington, DC 20546-0001			10. SPONSORING/MONITORING AGENCY REPORT NUMBER NASA/TM-2001-209037

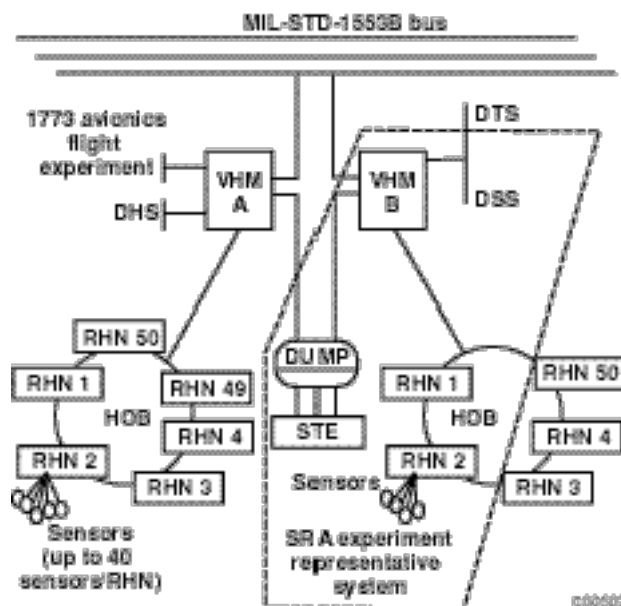
Figure 1. X-33/SRA configuration.

The X-33 VHM architecture (fig. 1) acquires data from a wide variety of sensors and systems. The system monitors and records all data on the vehicle, including all the flight bus data, all vehicle health data (structural, mechanical and system built-in test (BIT) status), and all the flight test instrumentation sensor data. This system interfaces to a NASA Jet Propulsion Laboratory avionics flight experiment that communicates over a MIL-STD-1773 fiber optic interface [2].

The VHM system uses a distributed sensing architecture to collect data from conventional sensors. The data are concentrated using 50 RHNs to gather structural, mechanical and environmental sensor data. Each RHN communicates with the VHM computer over a fiber optic health optical bus (HOB). The VHM computers (1) acquire data from the HOB, (2) monitor and record all MIL-STD-1553B data [3], and (3) gather fiber optic distributed temperature, hydrogen, and strain sensor data from digital signal processors which reside in the VHM computer. Optical sensors are mounted directly on the X-33 propellant tanks, while the driving optics and processing are housed in the VHM computers.

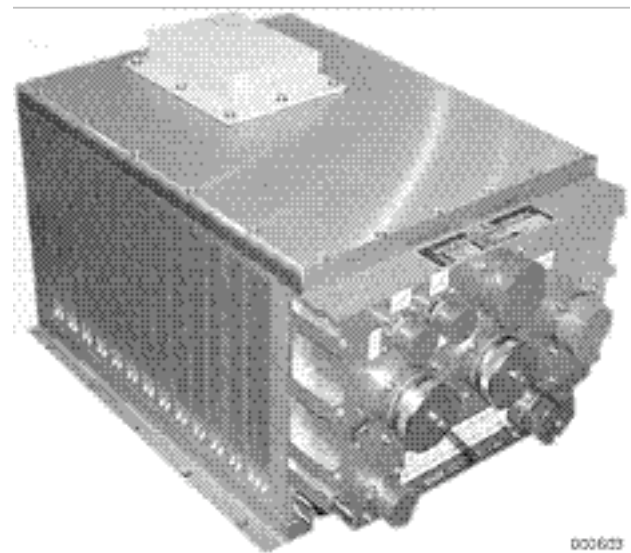
Figure 2. VHM-A/B.

The X-33 vehicle health manager-A (VHM-A) shown in figure 2 is one of two nearly identical versa-module-eurocard (VME)-based computers housed in a modified full air transportation rack chassis used to monitor and record data. VHM-A contains a commercial off-the-shelf or military off-the-shelf standard processor interfaced to a 4.5 gigabyte PC-based hard disk drive storage module and various input/output modules. VHM-A connects to 25 RHNs by means of the fiber optic HOB implementing an FDDI. The distributed fiber optic temperature sensors and MIL-STD-1553B bus monitors interface directly to the VHM-A computer. The VHM-A computer acts as a remote terminal by using a MIL-STD-1553B interface for VHM command and control information. VHM-B is nearly identical to VHM-A; the differences are that the VHM-B line replaceable unit contains the distributed fiber optic strain and hydrogen sensors. The VHM computer also handles telemetry downlink, recorder download, and system diagnostic functions.

The modified chassis design for the VHM computer (fig. 2) resulted in a box that would not fit in a standard avionics rack. As a result the computer was installed vertically on an instrumentation rack located in the gun bay on the SRA. This installation subjected the VHM computer to “off axis” loading for a significant portion of the test program.

VHM computer modifications included incorporation of GEN II fiber optic connectors and a multi-channel single-mode fiber optic connector for the DSS. Software modifications were made to integrate the system onto the SRA. These modifications changed the computer operating commands and time synchronization from a MIL-STD-1553B interface to an analog switch to command the recorder and an RS-422 interface to provide time synchronization. Additional changes included; changing to a single FDDI module for both the RHN network and the recorder download, and the use of solid-state memory replacing the hard disk drive.
